BASTIÓN DE SAN DIEGO

INTRAMUROS ADMINISTRATION
MINISTRY OF HUMAN SETTLEMENTS

The conservation of Bastión de San Diego began on March 17, 1979. This initial effort to clear the structure of vegetation and waste led to the discovery of interesting architectural features, many of them previously unrecorded and photographed.

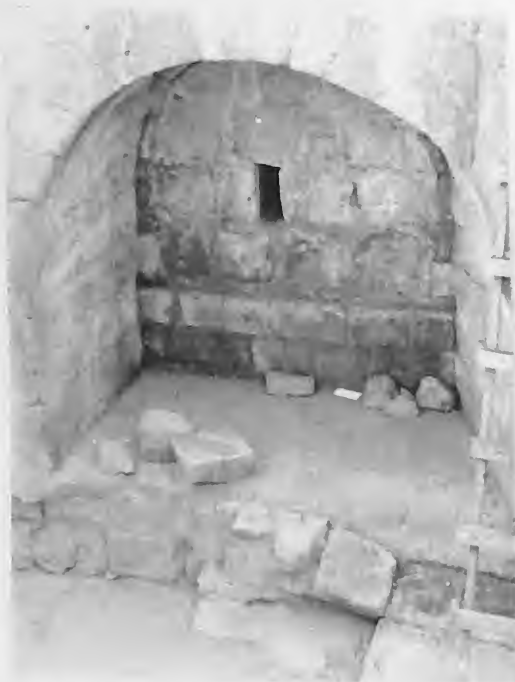
Figures 25, 26, 27. Casemates Nos. 4, 5 and 6, all located on the southwest quadrant, are simply arched chambers. All have the narrow apertures mentioned in Román's description of the old tower. They have taller arches but narrower width.

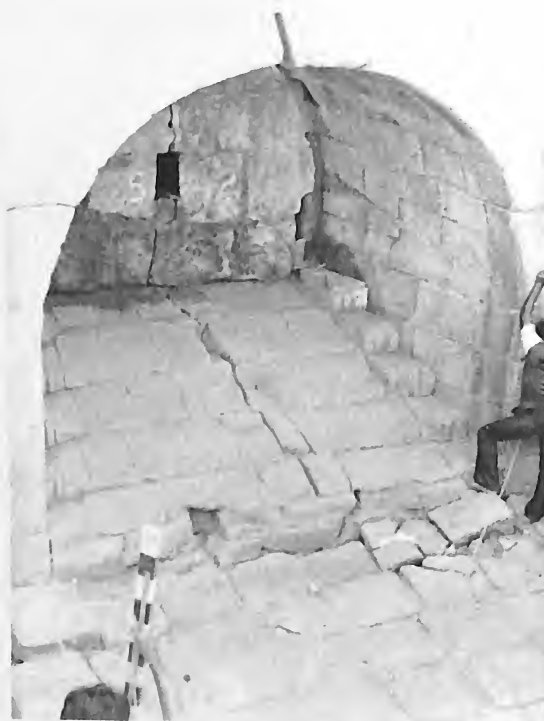
Casemate No. 5 has a gradually sloping floor, which could have been used for pushing the cannon up the ramp. It appears to have all the features of the older construction, even the paving outside its chamber.

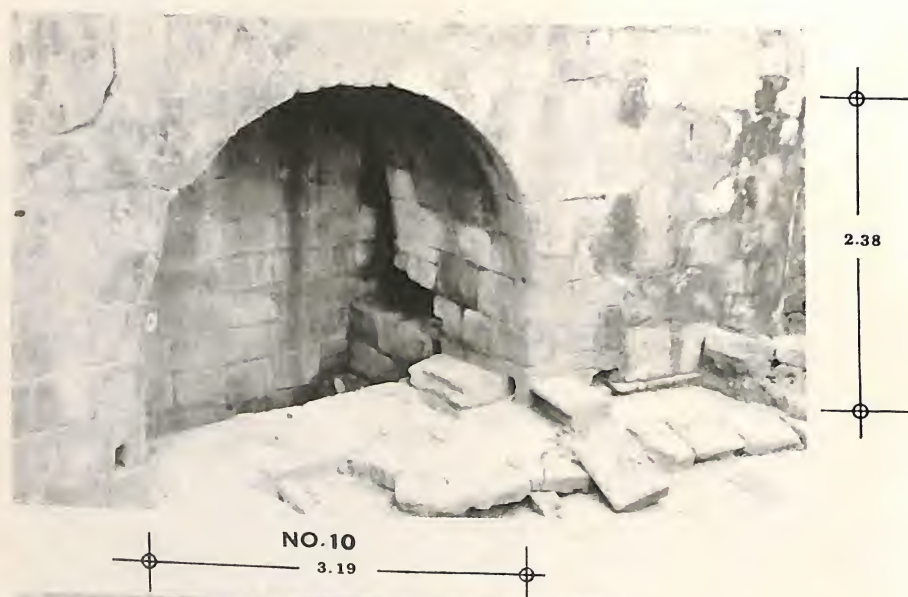
Figure 31. Casemate No. 10, which appears to belong to the same period as 4, 5 and 6, has a split-level flooring. The outer chamber is on the same level as the ground floor but its inner chamber has a deep trough several meters deep. Its arch is also semi-detached from the wall, revealing a tiny archway leading upward toward the spiral staircase. The entrance of the outer chamber has deep grooves which might have held some kind of door.

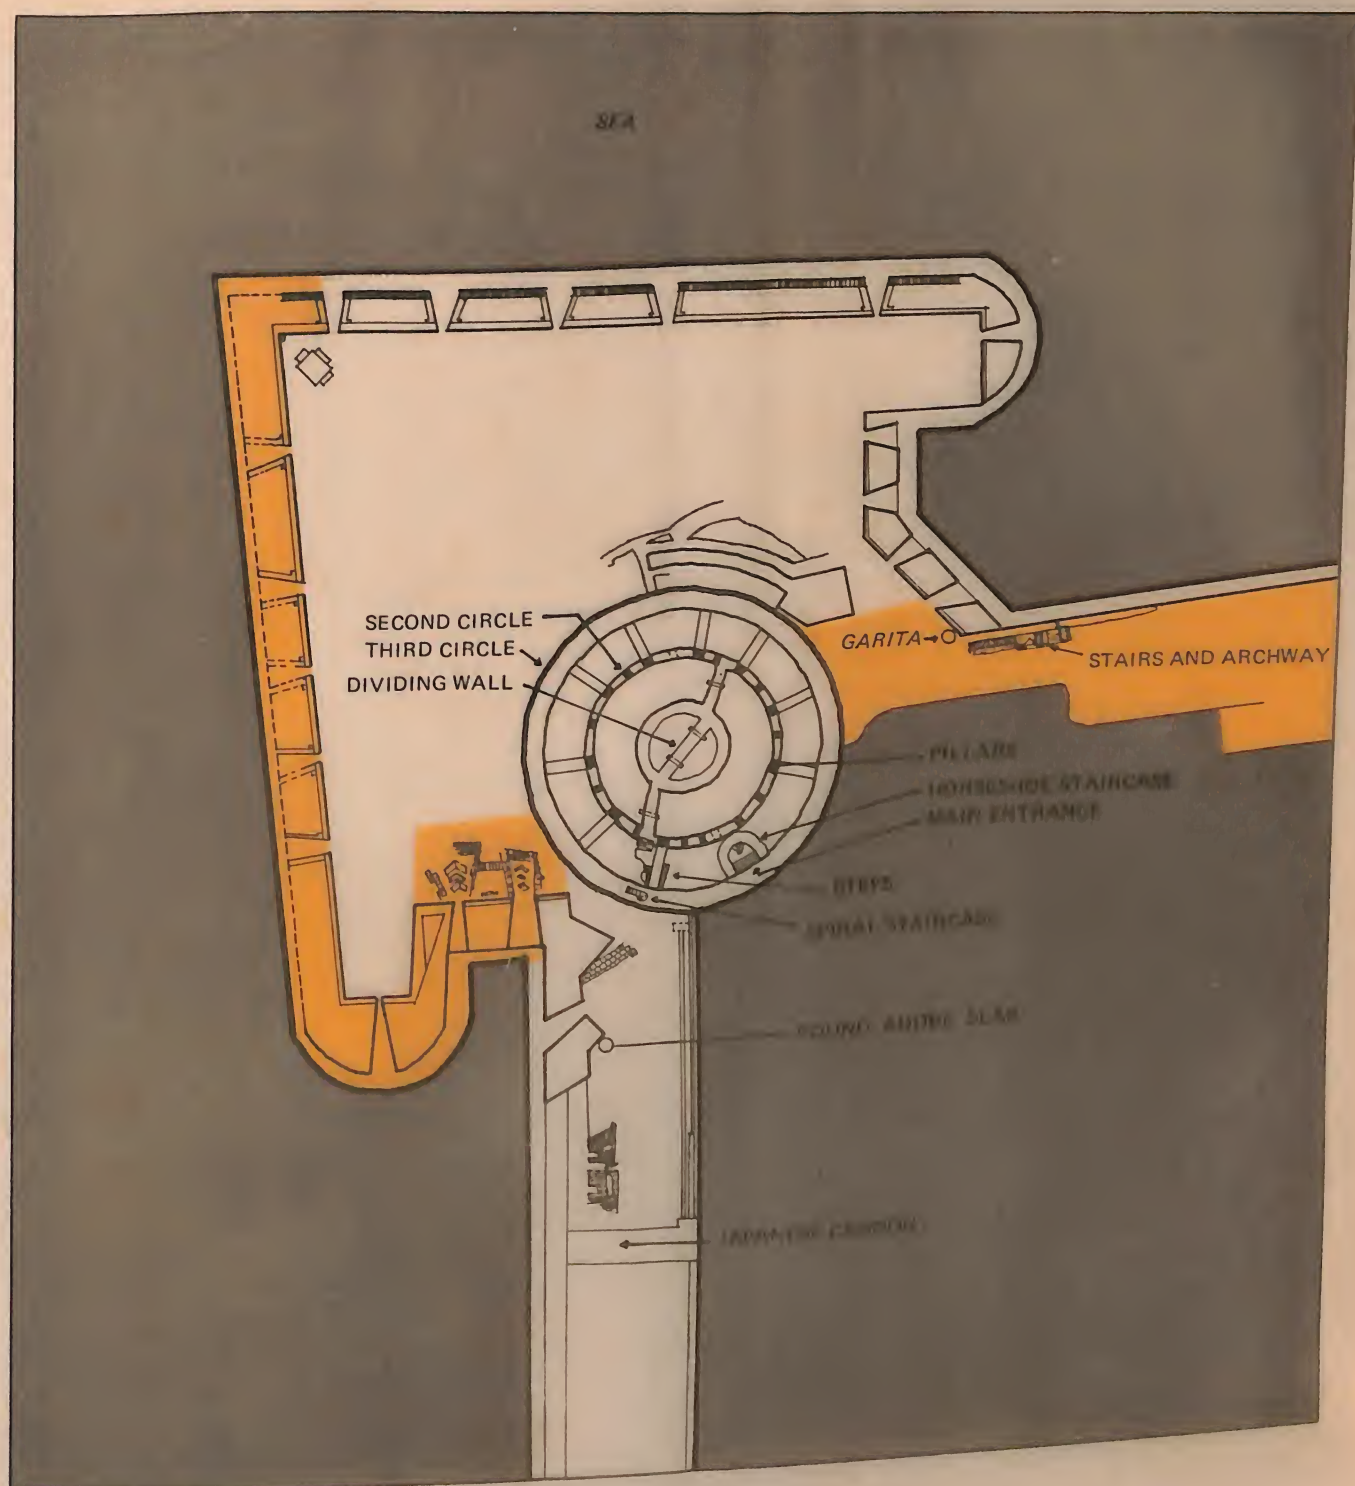
Figure 33. Bastión de San Diego shown at the end of the excavation in 1982. Besides the parapet and the lone garita on the north flank, various other structures appeared as the soil fill was removed: gun emplacements on the east orillon, stairs facing the tip of the bulwark and the three circular structures. Below the terreplein appeared the horseshoe staircase, the spiral staircase, the three sets of stairs sandwiched between the ground of the third and second circle, east quadrant; the subterranean courtyard to the west and the archway and stairs by the curtain wall on the north corner.

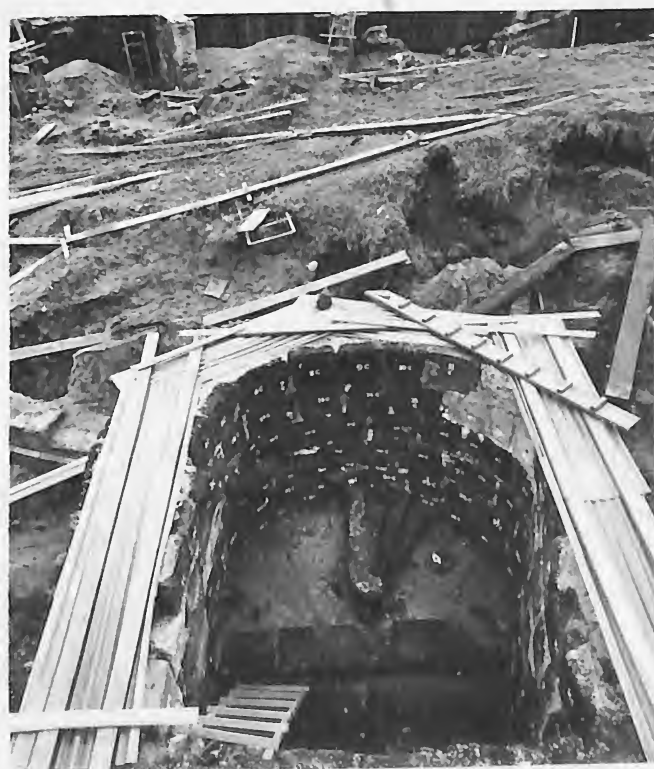
Figure 49. Top view of the horseshoe-shaped stairwell. On the landing are the remaining steps, spread out like a fan. Ridges left on the wall show the spiral ascent of the missing members of the stairs, which lead to the top of the bulwark.

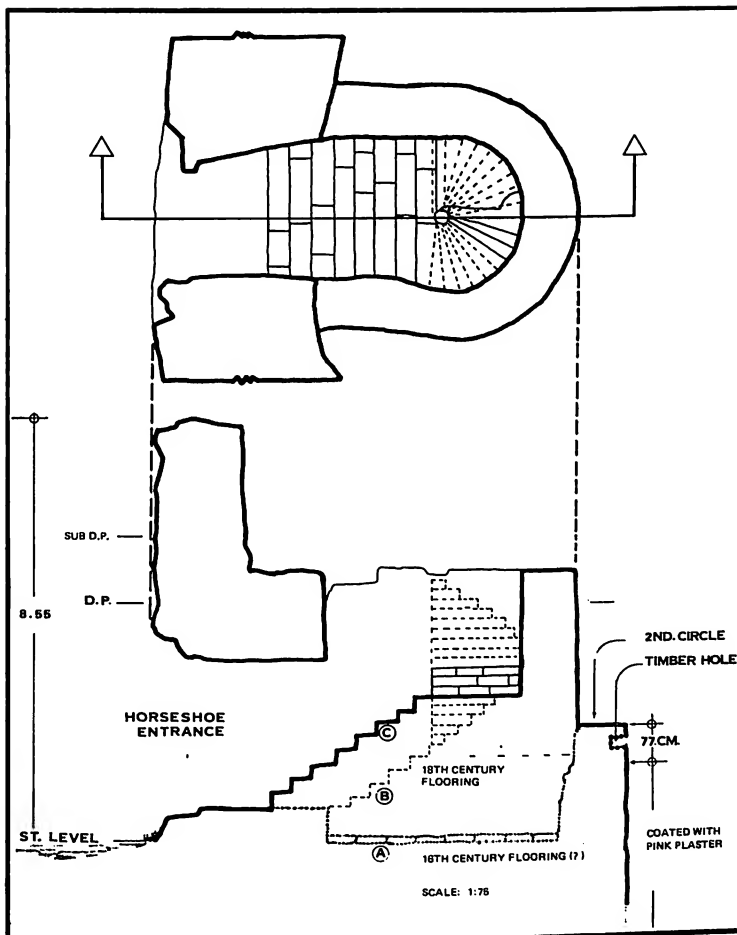
Figure 53. These sketches show the different elevations within and without the structure relative to the staircase. The present street level is almost on the same level as the flooring of an earlier period, possibly that of the 16th century. The present staircase appears to have been built on the older foundation.
